INDOOR AIR QUALITY ASSESSMENT

**Florence Sawyer School
100 Mechanic Street
Bolton, MA**

Prepared by:
Massachusetts Department of Public Health
Bureau of Environmental Health
Indoor Air Quality Program
November 2018

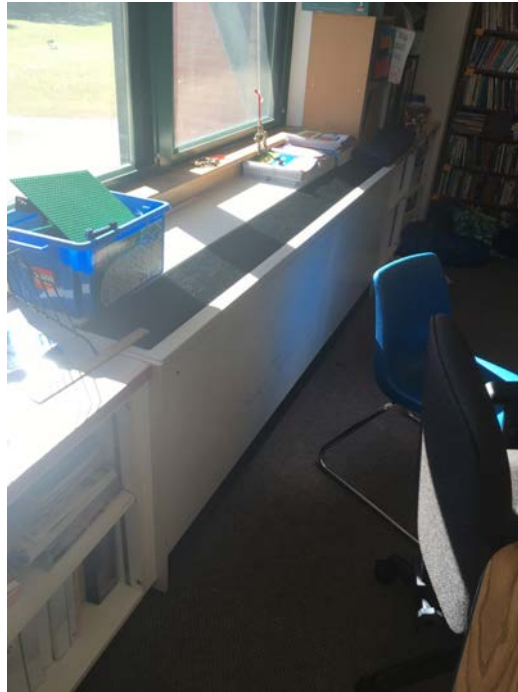
Picture 1

Fresh air is provided by a combination of unit ventilators (univents) located in most individual classrooms (Picture 1) and roof top air handling units (AHUs) for common areas (e.g., library, gymnasium, etc.). The univents draw fresh air through a vent on the exterior wall (Picture 2). Air is mixed with return air from the room, filtered, heated (if needed) and delivered to the room ([Figure 1](#)). Some univents were obstructed by items placed on top or in front (Picture 3). Both the top and the vent at the bottom need to be kept clear of obstructions for the units to operate as designed. Air from the AHUs is filtered, heated or cooled as needed, and delivered to rooms via ducted supply vents (Picture 4).

Univent in classroom

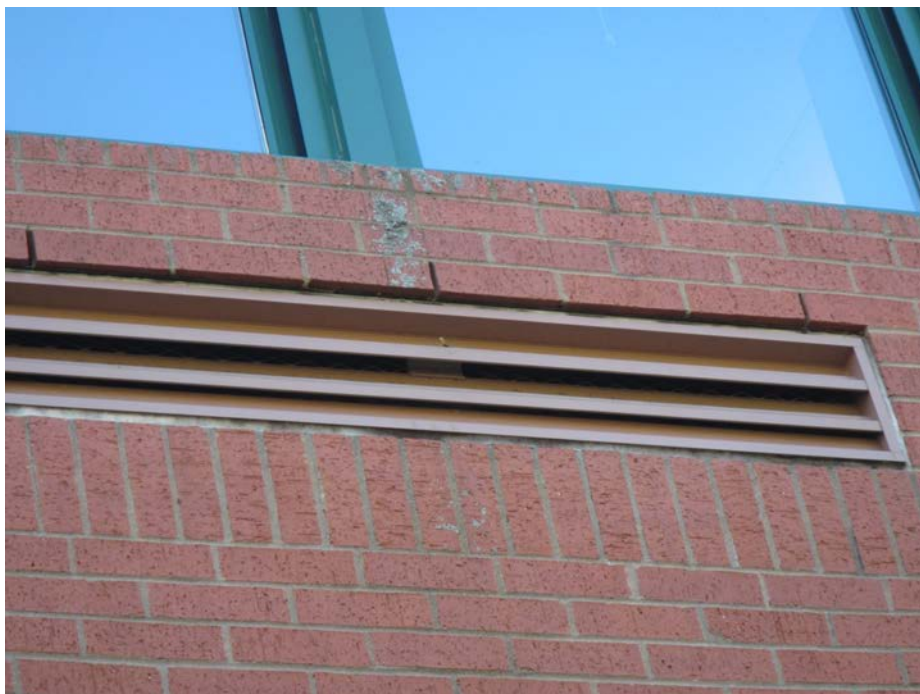
Picture 2

Exterior fresh air intake vent for classroom univent

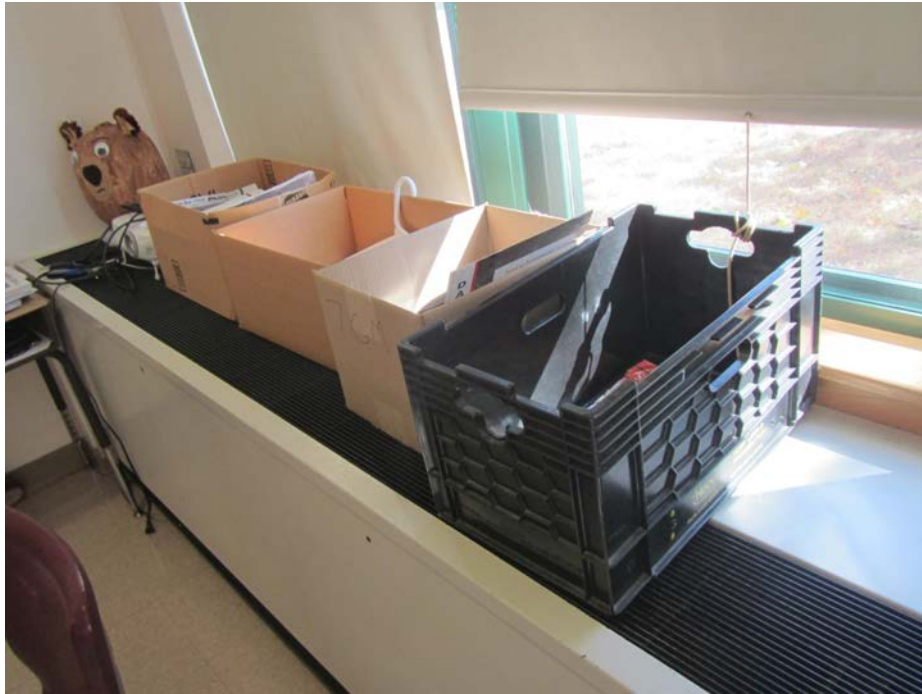
Picture 3

Univent with items obstructing supply air flow

3. Remove items and furniture blocking univents both on top and along the front.
4. Educate occupants that the univents provide not only heat but fresh air and should never be shut off. Temperature/comfort complaints should be made through proper channels and followed up by facilities staff.

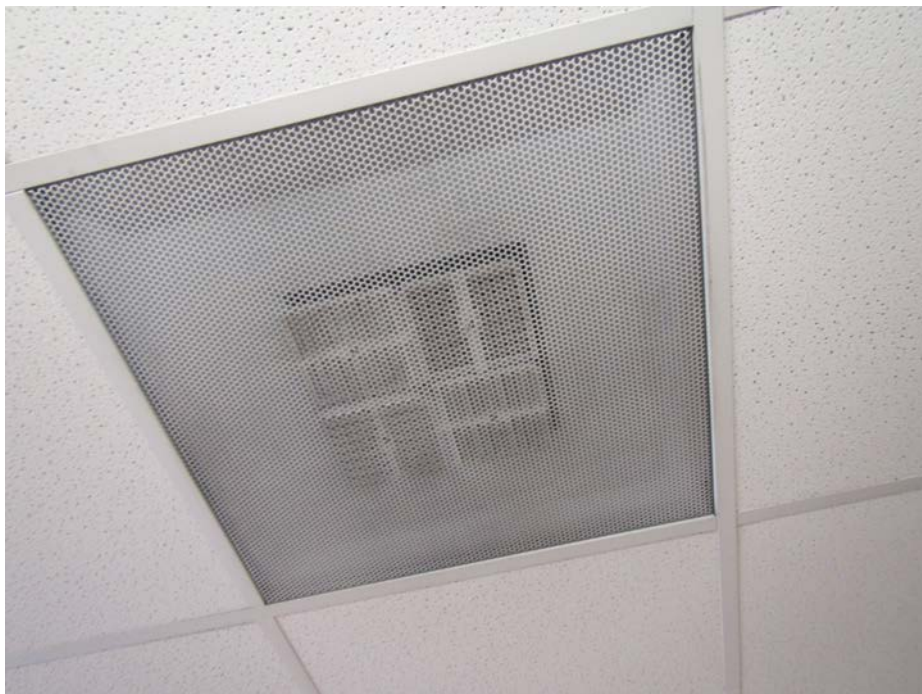
Picture 4

Ceiling-mounted supply air diffuser ducted from AHU

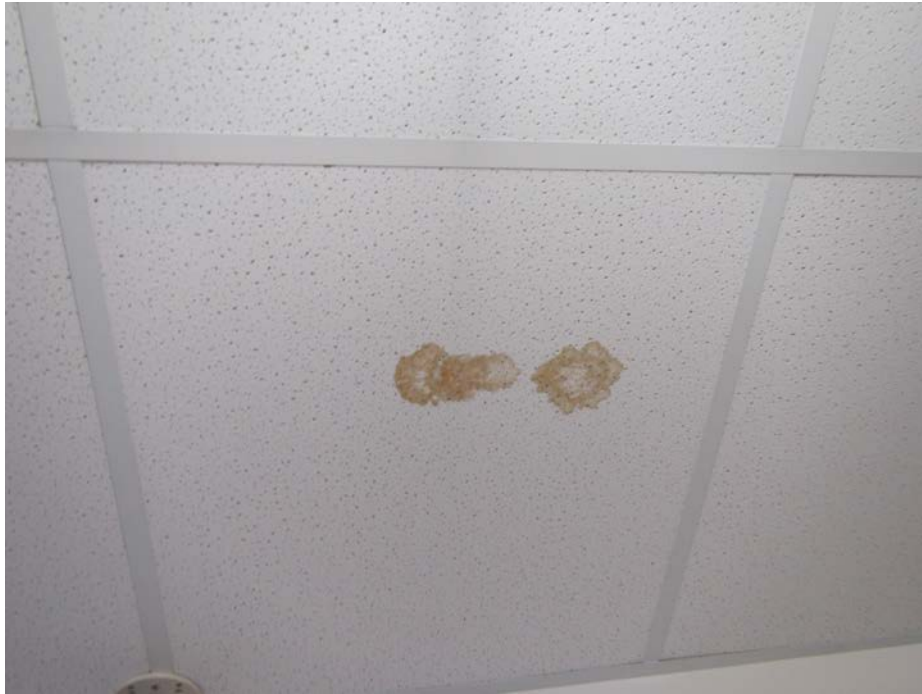
Picture 5

Water-damaged ceiling tiles were observed in a few areas (Picture 5, Table 1), which indicate leaks from the building envelope or plumbing system. In most cases, these leaks were reported to be historic (i.e., inactive). These tiles should be replaced after the leak is found and repaired.

Water-damaged ceiling tile

13. Ensure roof and plumbing leaks are repaired and replace any remaining water-damaged ceiling tiles and building materials.
14. Inspect any stored supplies or porous items (e.g., books, papers, boxes, etc.) in areas prone to chronic moisture (e.g. slab floors). Discard any porous items noted to be water-damaged or have a musty odor. Store porous items on shelving and away from walls.

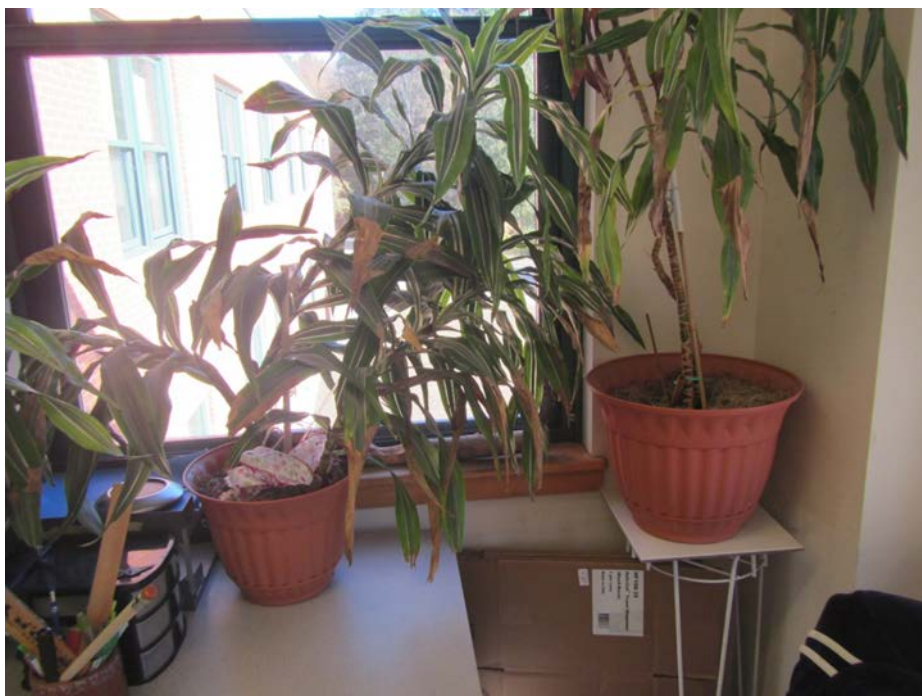
Picture 6

Indoor plants were observed in a few areas (Picture 6). Some of these plants were placed on porous materials. Plants can be a source of pollen and mold, which can be respiratory irritants to some individuals. Plants should be properly maintained, equipped with non-porous drip pans, and should be located away from air diffusers to prevent the aerosolization of dirt, pollen and mold.

Plants located in occupied space

20. Properly maintain plants, including drip pans, to prevent water damage to porous materials. Plants should also be located away from air diffusers to prevent the aerosolization of dirt, pollen, and mold.

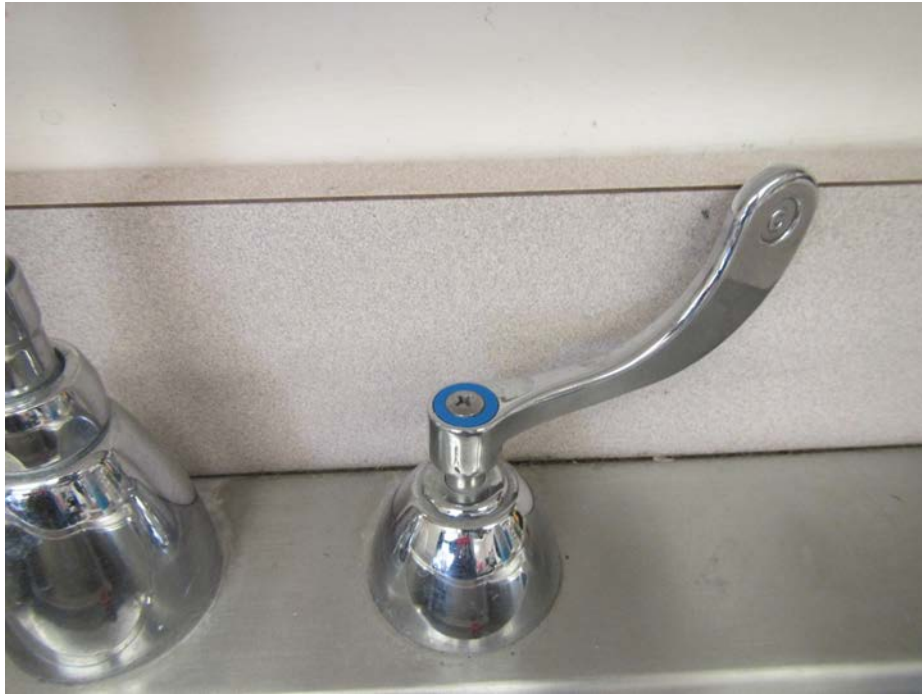
Picture 7

Some classroom sinks were noted to have a gap between the counter and the backsplash (Picture 7; Table 1). This condition may allow chronic moisture to porous building materials which may lead to microbial growth.

Gap between sink and backsplash

21. Seal any gaps between the sink counter and backsplashes with appropriate caulking.
22. Eliminate the use of products and equipment that contain VOCs (e.g., air fresheners, scented cleaning wipes, scented hand sanitizer, etc.).

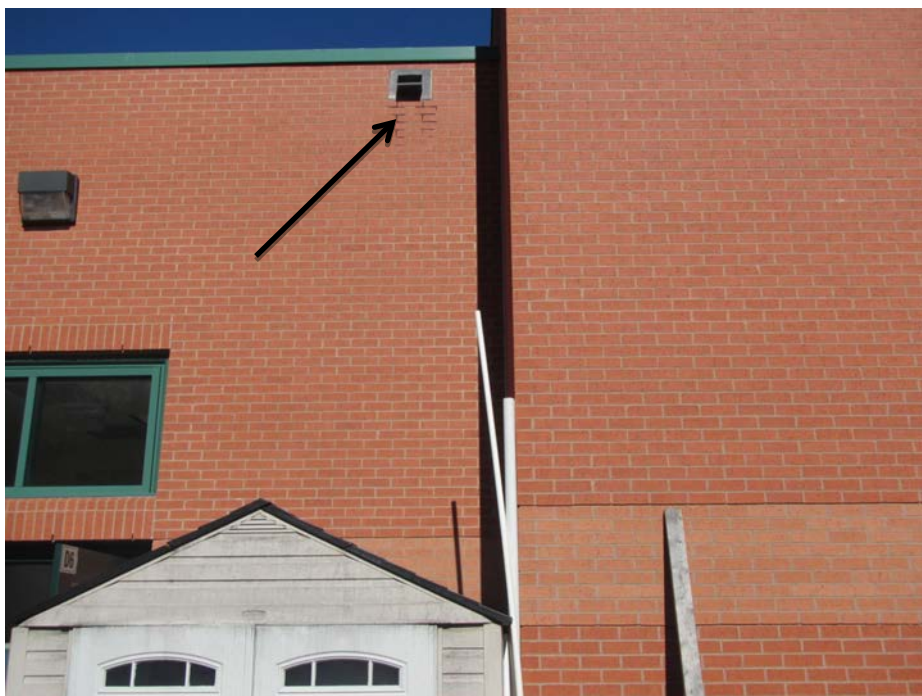
Picture 8

An inspection was conducted of the building exterior to identify other issues which could lead to water penetration. Overflow scuppers draining against the building exterior were noted (Picture 8). Some weep holes were found covered by soil/mulch (Picture 9). These weep holes should be kept clear to allow the free draining of water from the inner drainage plenum which has penetrated the brick. Also, vegetation was growing on or against the building, some of which

Overflow roof scupper drains on shed below and against building

15. Regularly inspect roof drains to ensure they are free from debris and allow for proper drainage and prevent unnecessary use of overflow scuppers.
16. Consider removing the shed beneath the overflow scupper to avoid water splashing against building exterior.

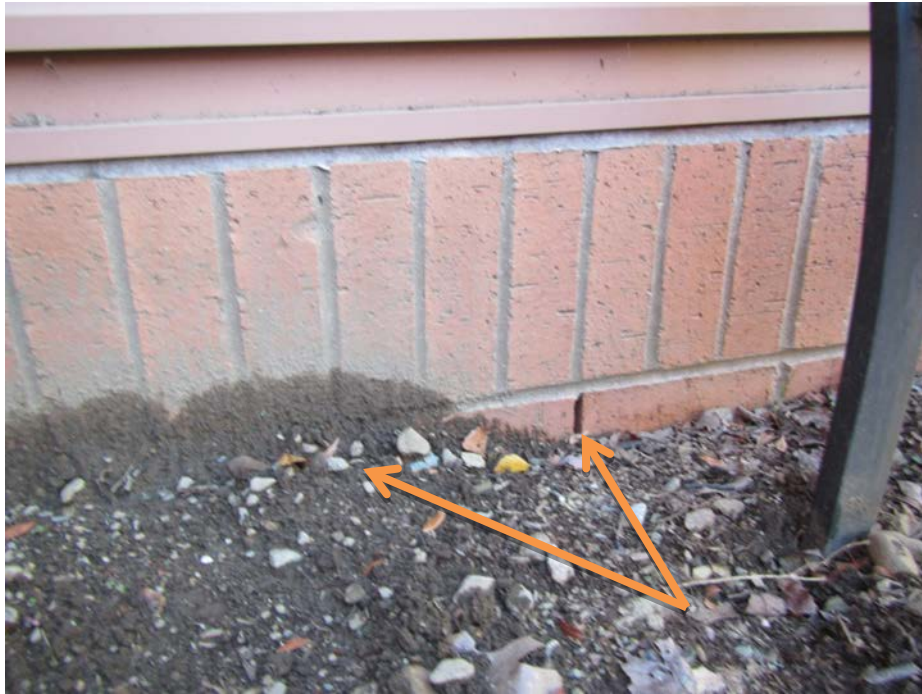
Picture 9

Weep hole (right arrow) and higher backfill covering other weep holes to the left

17. Inspect all weep holes to ensure they are not covered with soil/mulch and allow for the free draining of water from inner drainage plenum.
18. Remove any vegetation growing on or within 5 feet of the building.

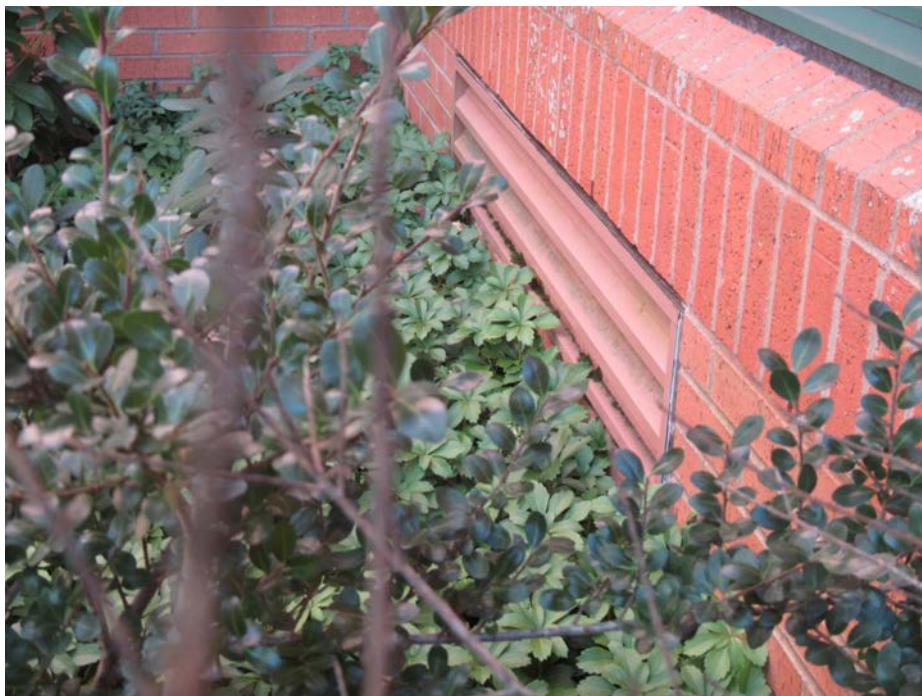
Picture 10

was growing in front of fresh air intakes for univents (Picture 10). Lastly, the ground outside of room #136 appeared to be chronically moist. This side of the building does not receive sunlight so that it remains damp. In addition, the grading of the surface allows water to collect in a depression against the perimeter of the slab (Picture 11). Concrete can have a wicking effect to produce chronically moist conditions above the slab in this area.

Vegetation against building and univent

25. Consider reducing the amount of items stored in classrooms to make cleaning easier. Periodically move items to clean flat surfaces.
26. Univent fresh air intakes on the exterior of the building should be monitored for debris and cleaned periodically. Ensure any vegetation is removed that is growing in front of these air intakes.

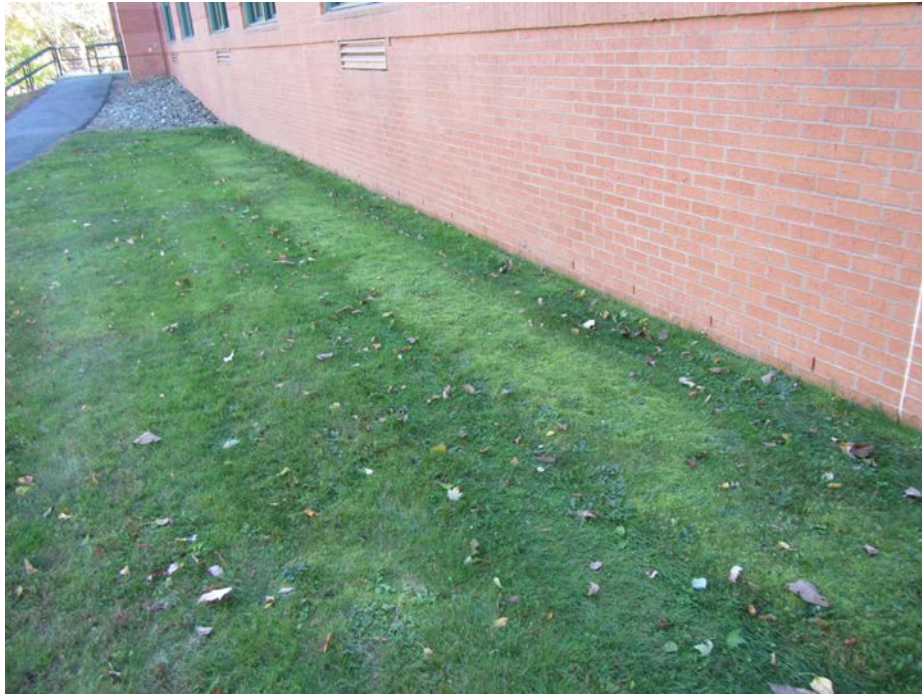
Picture 11

Improper grading showing depression which allows water to collect against building

19. Consider re-grading the area outside of room #136 to allow storm water to drain away from the building exterior rather than pool adjacent to building slab.

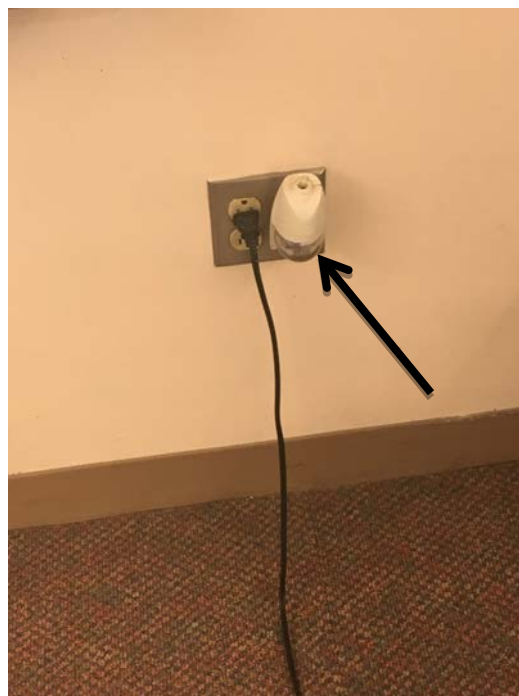
Picture 12

Plug-in air freshener

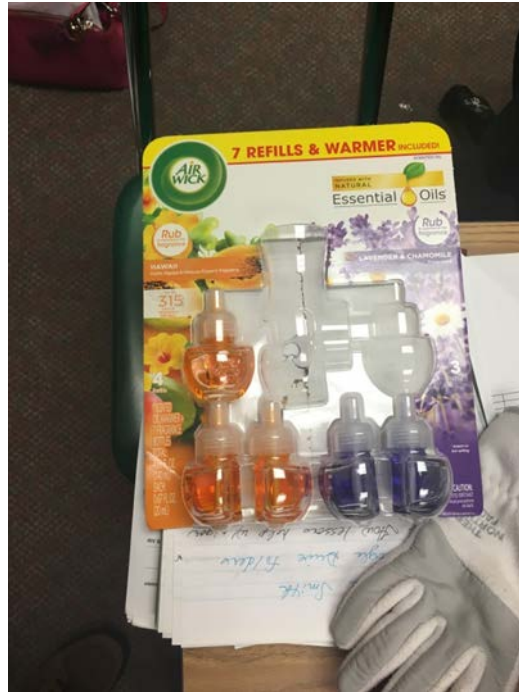
Picture 13

Fragrance refill package

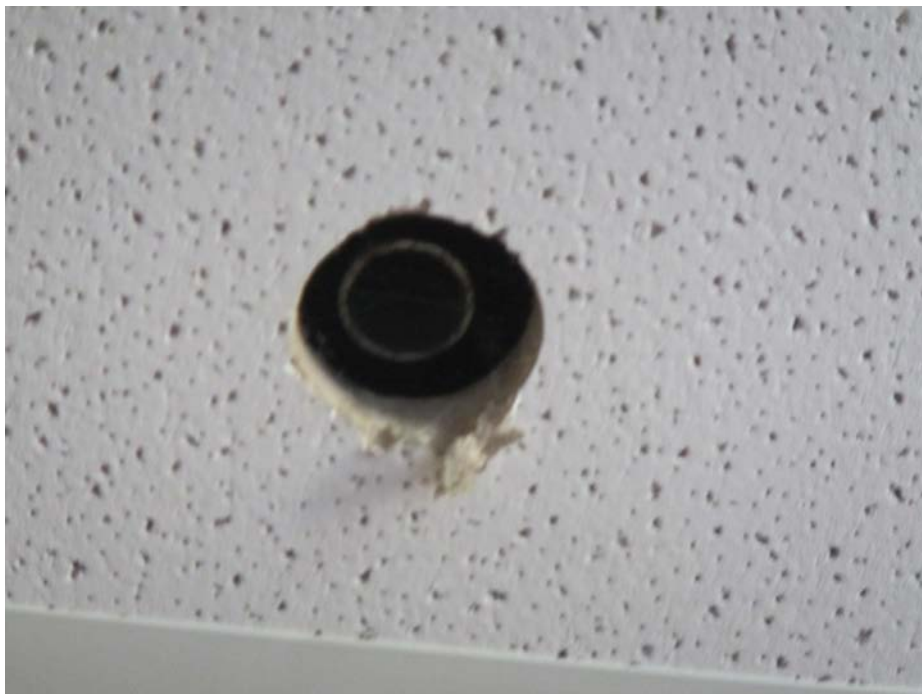
Picture 14

BEH staff noted that the univents have a small hole in the cabinet that may draw air from unconditioned areas and bypass the filter. Other pathways such as holes in ceiling tiles or around utilities were also discovered (Picture 14).

Hole in ceiling tile showing abandoned utility pipe

9. Remove any carpeting exposed to chronic moisture/condensation (e.g., rooms on slab).
10. Seal any holes within univent cabinets to ensure that no air bypasses the filter. Seal other pathways in walls, floors, and ceilings (e.g., around utilities).
